Manhole Inspection Summary

Manhole # S08EE2005MH

Insp Date: **9/21/06 10:59 AM**

Location Address: **3703 SEVEN MILE LN**

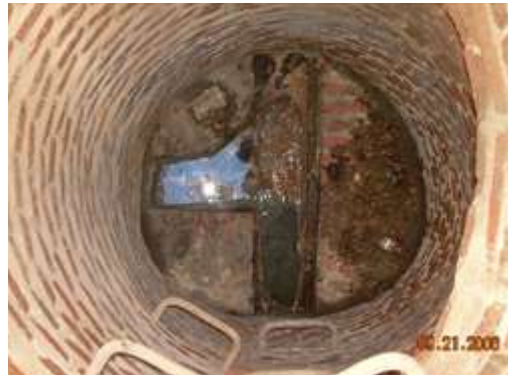
Top View

Adjustment and Barrel infiltration.
Evidence of surcharge - Bench debris.

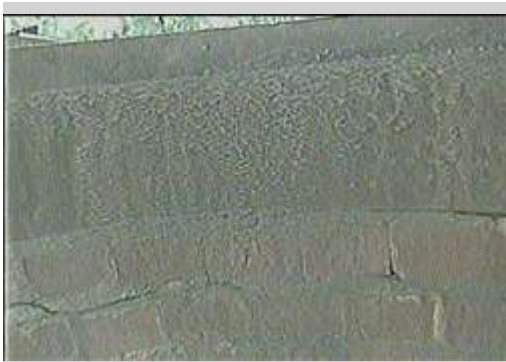
Defect

Frame leaks. Adjustment deterioration
and infiltration.

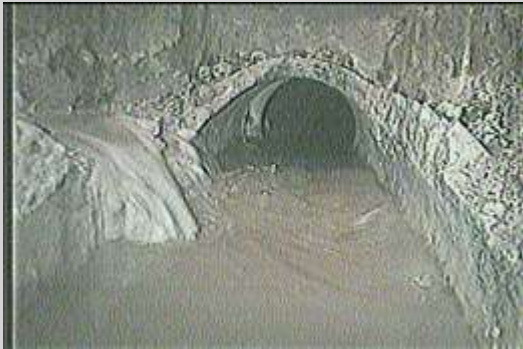
8 in. Circular Gravity Sewer Pipe Out @ 12 O'Clock

Comments **The I6 pipe is deeper than the O12 pipe. This is causing water to build up so it can continue out.**

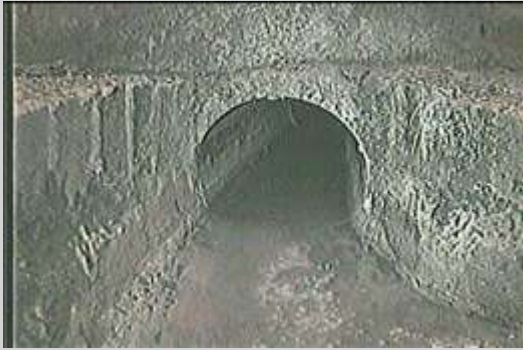
Pipe In @ 9 O'Clock

Deposits: ☐ None ☐ Mud ☐ Sludge ☐ Debris ☒ **Grease**

Silt Depth: **0** (in.) Deposits Extent: **Light**

Pipe Seal Cond: **Cracked**
